**Inspection Date:** Aug 21, 2025

**Roof Area:** 1.0, 2.0, 3.0

**Project Name:** SCC No. 309

**Type of Roofing Project:** Replacement

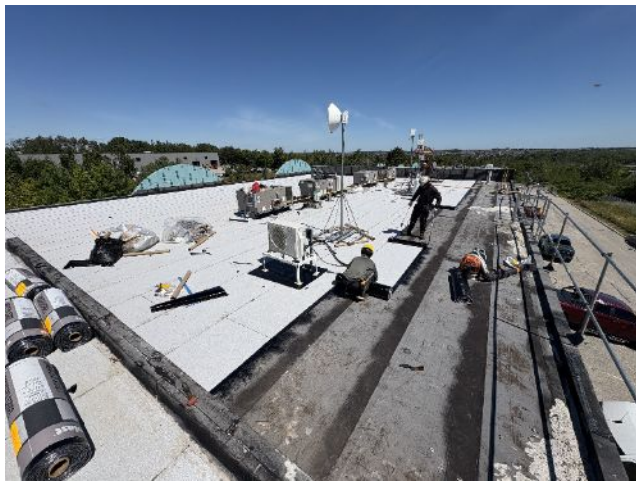
① Description:

An overview photo showing the roofers installing the cap sheet membrane in the field of roof level 3.0

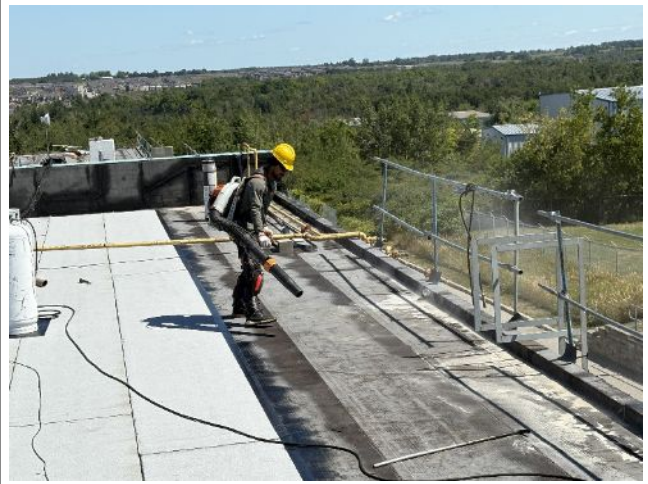
② Description:

A roofer using a gas powered blower to clean and remove any debris from the base sheet substrate to provide a clean surface prior to installing the cap sheet membrane.

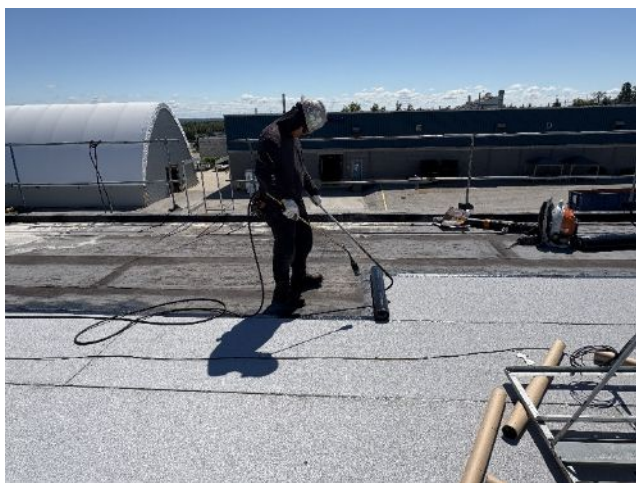
③ Description:

A crew member using a propane torch and torch roll cane to install the cap sheet membrane.

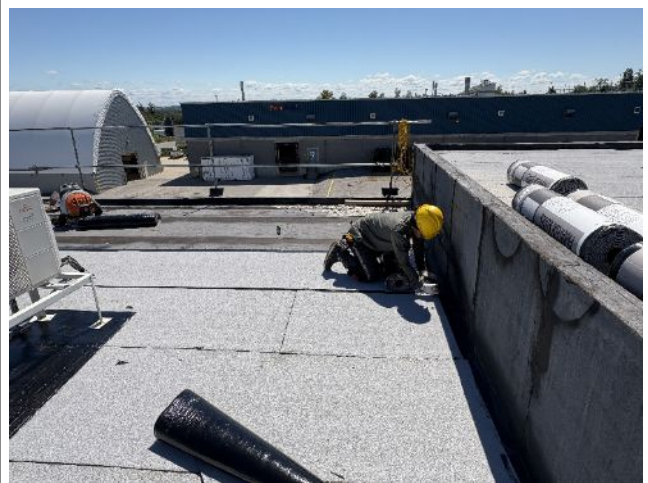
④ Description:

Another worker pre-cutting the rolls of cap sheet and allowing the membrane to relax prior to installation.

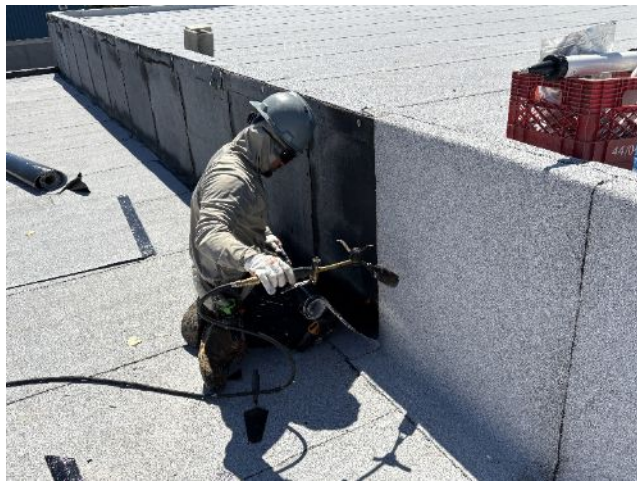
⑤ Description:

The roofers began to install the cap sheet membrane along the parapet wall separating roof levels 1.0 and 2.0. The workers used a 2" roller to ensure proper adhesion and adequate bleedout between the membrane laps.

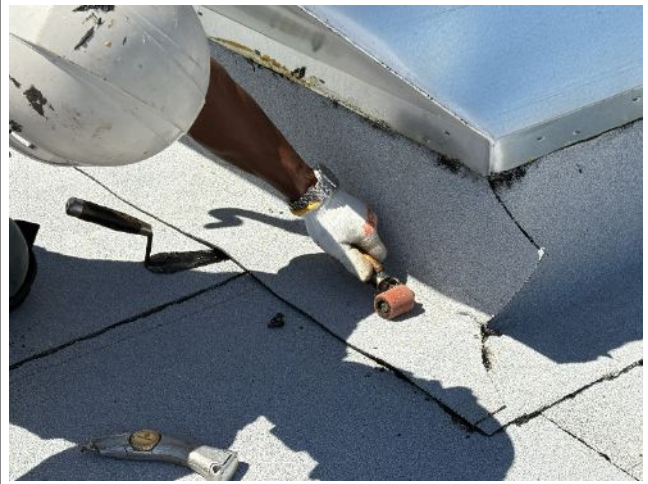
⑥ Description:

A crew member using a 2" roller to apply pressure while installing the cap sheet flashing along the curb of an HVAC unit.

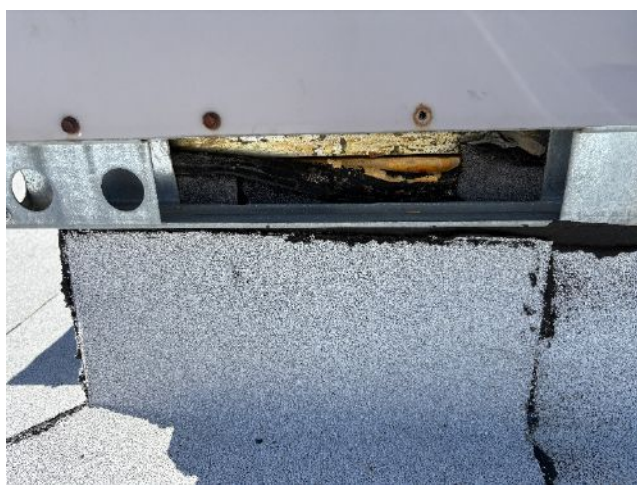
⑦ Description:

While inspecting the curb flashing details of the HVAC units it was observed that some of the membranes were installed inadequately. This was immediately brought to the attention of the foreman on-site and also to his field supervisor. It was agreed that this needed to be addressed and a meeting with all parties was scheduled for the following morning to go over the curb details.

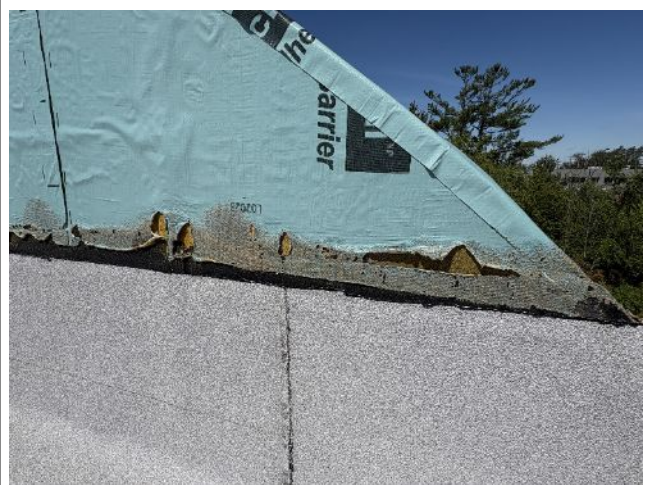
⑧ Description:

It was also observed that several areas of the parapet vapour barrier had become damaged due to the torching of the of the cap sheet flashing membranes. Again, this was brought to the attention of the roofing crew and they assured that the necessary repairs would be performed. A new piece of self-adhesive membrane will be required to be installed at this detail.
